RE: Revised Vapor Intrusion Report
Former Solutia – John F. Queeny Plant
St. Louis, Missouri
EPA ID No. MOD 004 954 111

**VAPOR INTRUSION
WORK PLAN IMPLEMENTATION REPORT**

Former Solutia Queeny Plant

St. Louis, Missouri

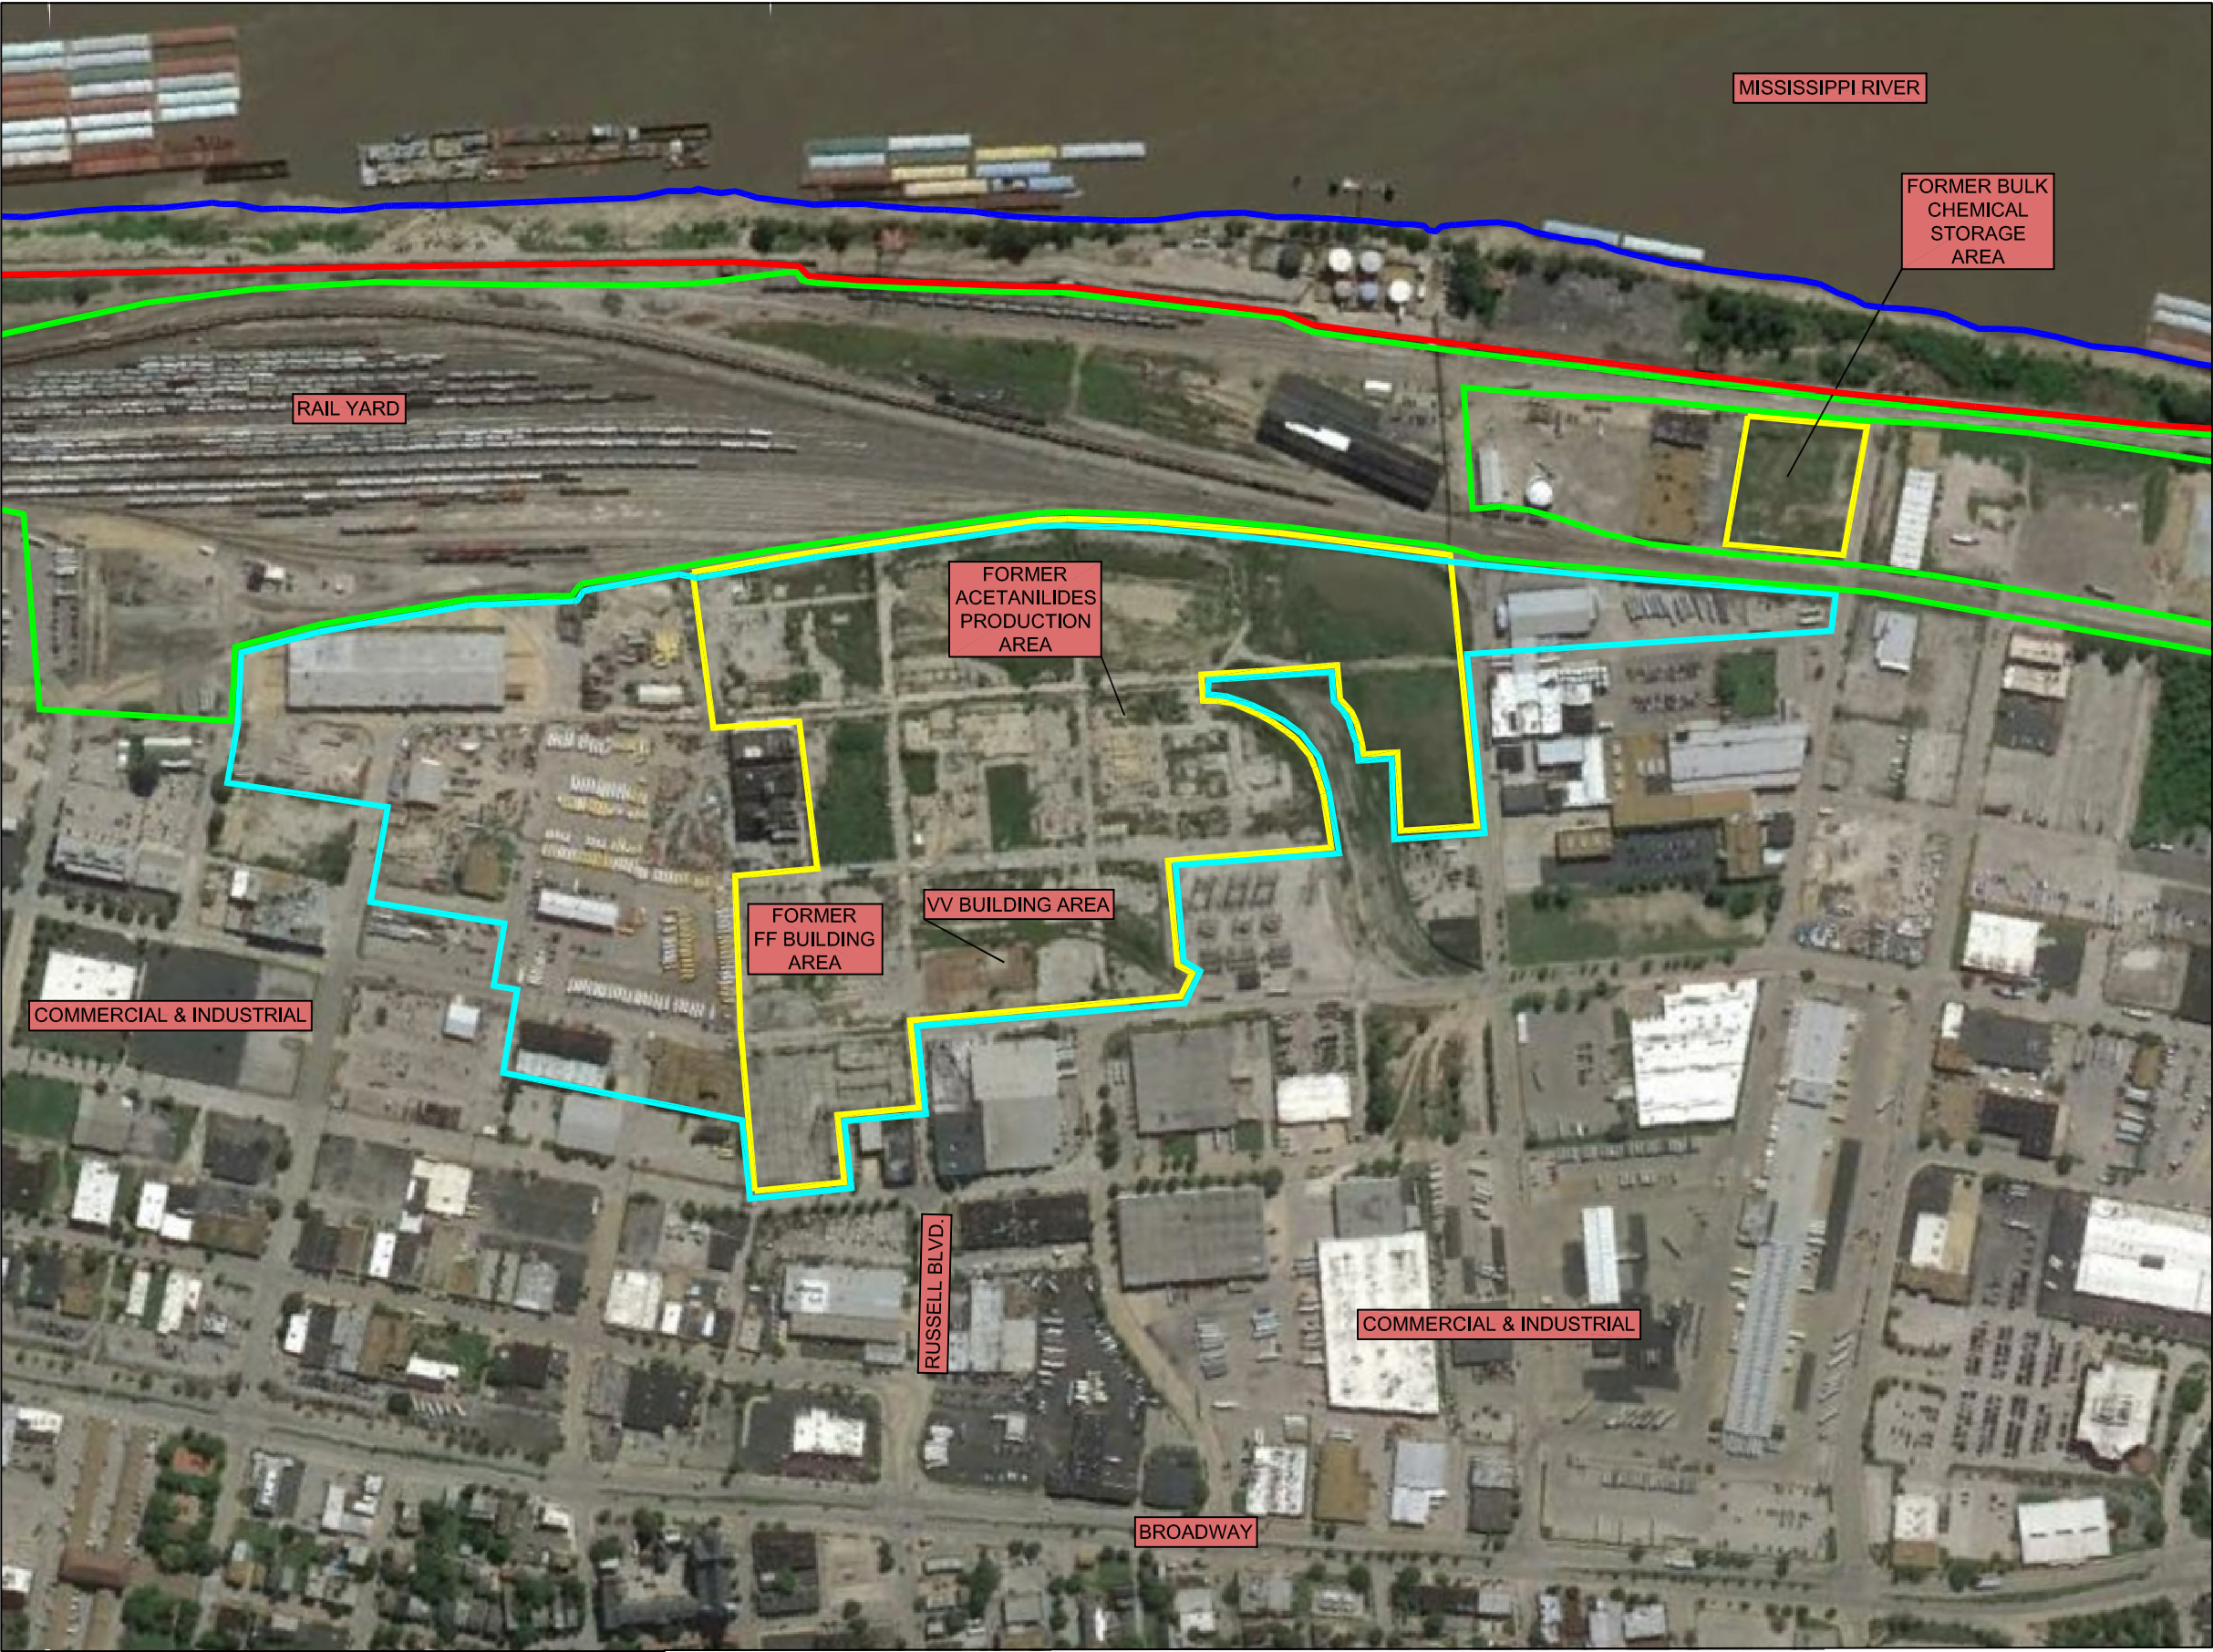
- LEGEND**
- PERIMETER OF SOLUTIA PROPERTY
 - HISTORICAL/MAXIMUM PERIMETER OF SOLUTIA PROPERTY
 - PERIMETER OF RAIL YARD & RAILROAD RIGHT-OF-WAY
 - EDGE OF THE MISSISSIPPI RIVER
 - U.S. ARMY CORPS OF ENGINEERS FLOODWALL
